**Stone Cover LLC, UTU 88492, S/027/0114**

**BUREAU OF LAND MANAGEMENT      FILLMORE FIELD OFFICE**  
**3809 Surface Management      FIELD COMPLIANCE INSPECTION FORM**

DATE: February 7, 2013

CASE FILE NUMBER: UTU 88492

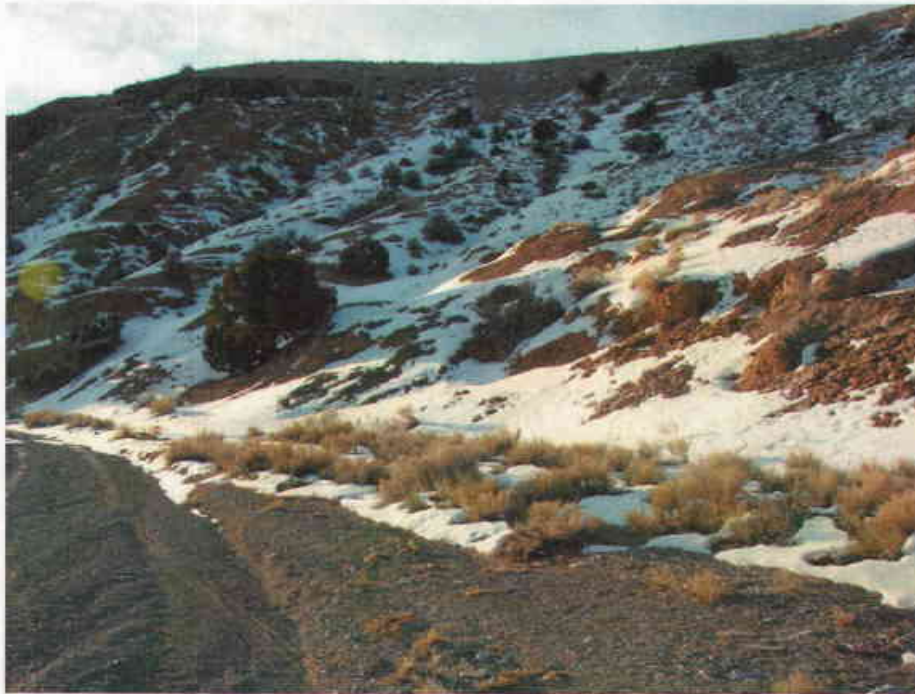
**Photo DSC02549 – View of hillside where sample was removed from west end of site facing southeasterly.**

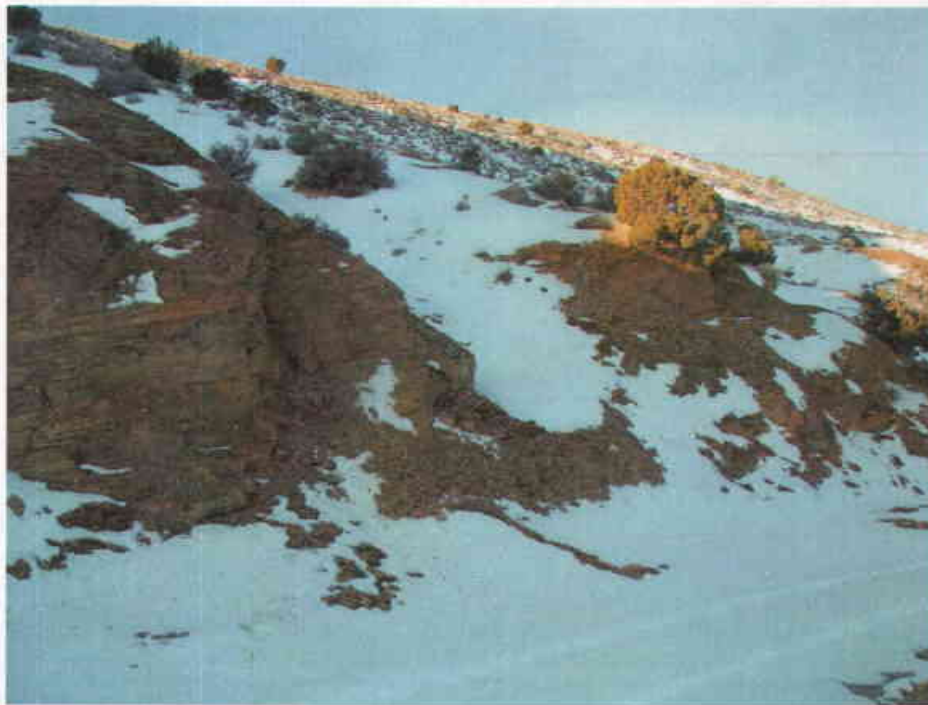
**Photo DSC02550 – View of hillside where sample was removed from east end of site facing southwesterly.**

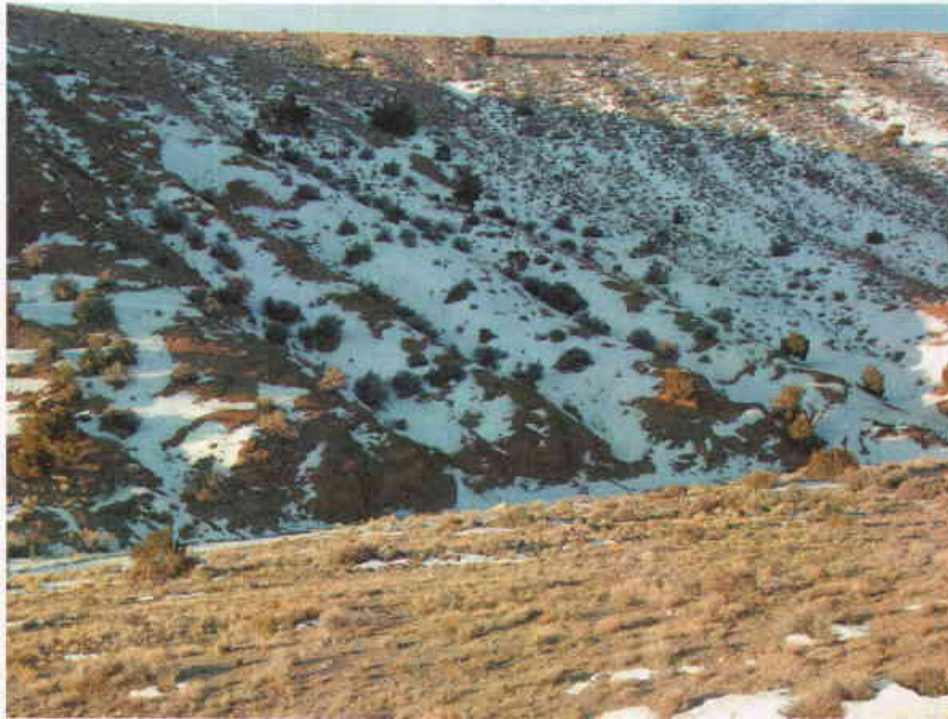
**Photo DSC02553 – View of south end of hillside where sample was removed facing southerly.**
